Analysis of Renovation Works in Cappuccinelli Social Housing District in Trapani

Rossella Corrao ^{1,*} , Erica La Placa ¹ , Enrico Genova ² and Calogero Vinci ¹

Keywords: social housing; renovation works; energy efficiency improvement; Cappuccinelli Social Housing district; Trapani

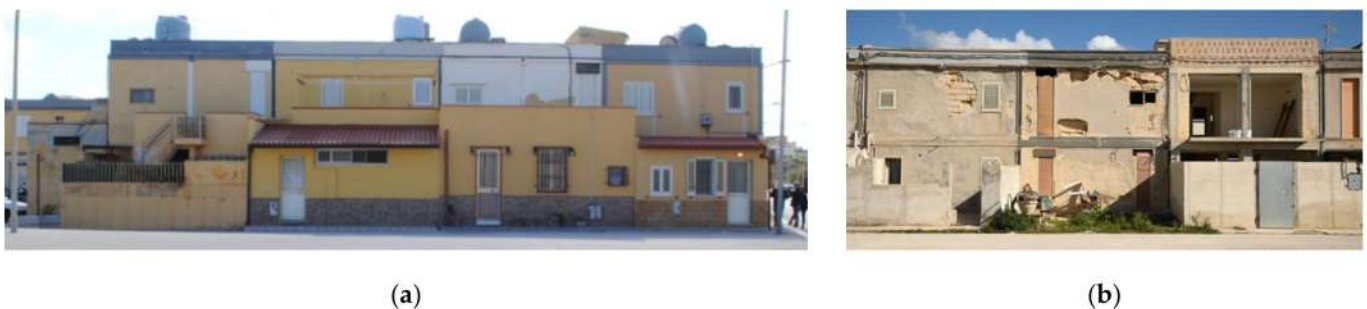
The phenomena of social decay impacted Cappuccinelli from the beginning. Many houses were illegally occupied even during the construction work, thus impeding the completion of the district according to the original project plan. Furthermore, unauthorized additions have proliferated: The small courtyards of paired duplexes were frequently closed and many private gardens in the large courtyard were changed to indoor spaces (Figure 2).

Figure 2. Unauthorized additions in the Cappuccinelli district: private gardens occupied by new rooms (a) and other chaotic modifications (b) in the terraced block named “L”.

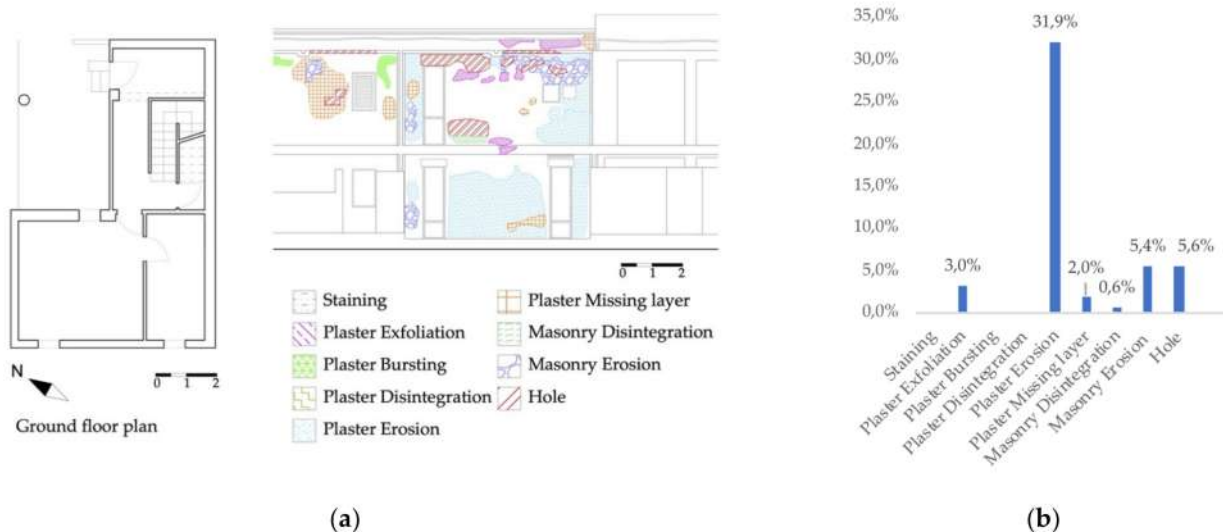
Figure 5a represents portion A (Figure 4) of the original plan (the project by Valori) and the southwest elevation of the “L” block and identifies its degradations: plaster exfoliation, plaster erosion, lack of plaster portions, masonry disintegration, masonry erosion, and lack of masonry blocks. In Figure 5b, the extent of each degradation phenomenon is estimated as a percentage of the analyzed surface. Plaster erosion is prevalent (31.9%), while other degradations range from 0.6 to 5.6%.

Figure 5. Ground floor plan from Valori project and representation of external visible damages on the façade (a), their extent estimated as a percentage of the analyzed façade surface (b) in the portion A (Figure 4) of the SW elevation of the “L” block. Authors: Erica La Placa, Calogero Vinci.

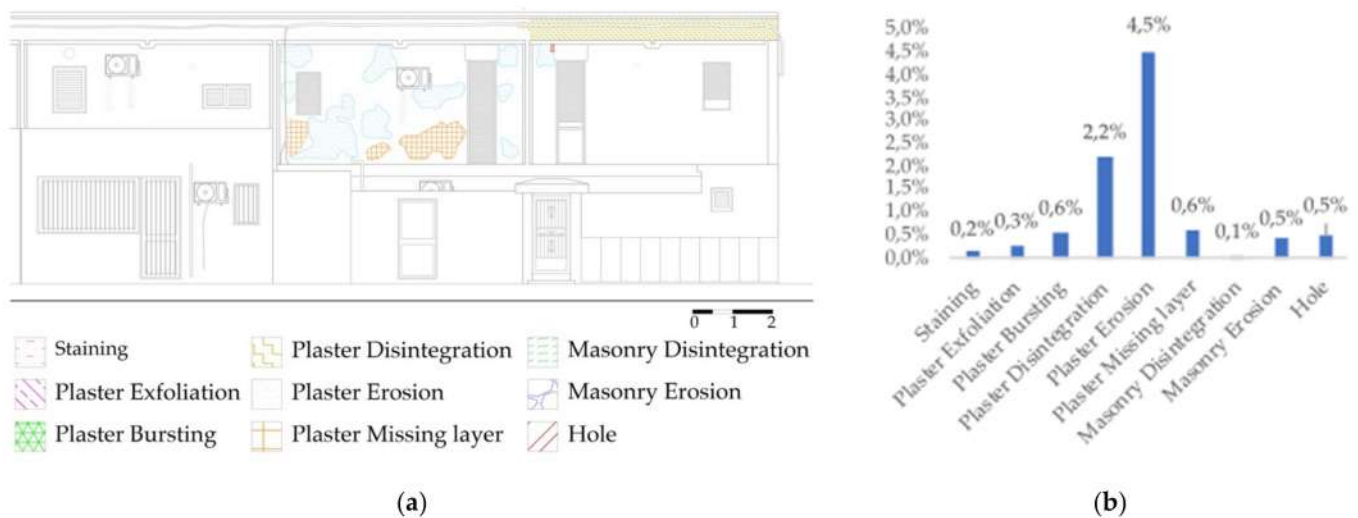
By extending this analysis to the entire “L” block (Figure 6a), erosion is confirmed as the most frequent degradation (4.5%) in all dwellings whose ownership passed from the public subject (IACP) to the private (original renters) (Figure 6b).

Figure 6. (a) Degradations of the portion B of the S-W elevation of “L” block in private dwellings. (b) Estimation of degradations as percentage of the analyzed surface. Authors: Erica La Placa, Calogero Vinci.

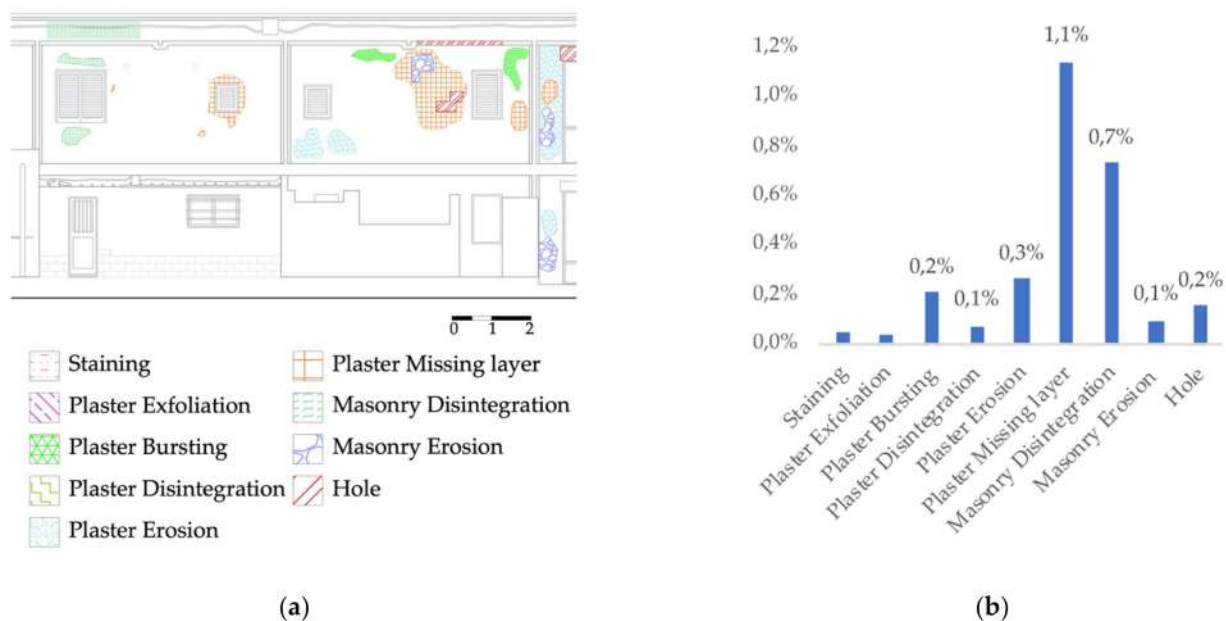
If the part still owned by IACP is considered (Figure 7a), the most recurrent deterioration is the lack of plaster portions (1.1%) (Figure 7b). More generally, the most frequent degradations on the façades of “L” block involve plasters. Indeed, the materials used for this functional layer were not suitable to calcarenite. Being very porous, this stone easily absorbs marine moisture and its content of salts, accelerating the mechanisms of the observed degradations.

Figure 7. (a) Degradations of the portion C in the SW elevation of “L” block in dwellings still owned by IACP. (b) Estimation of degradations as a percentage of the analyzed surface. Authors: Erica La Placa, Calogero Vinci.

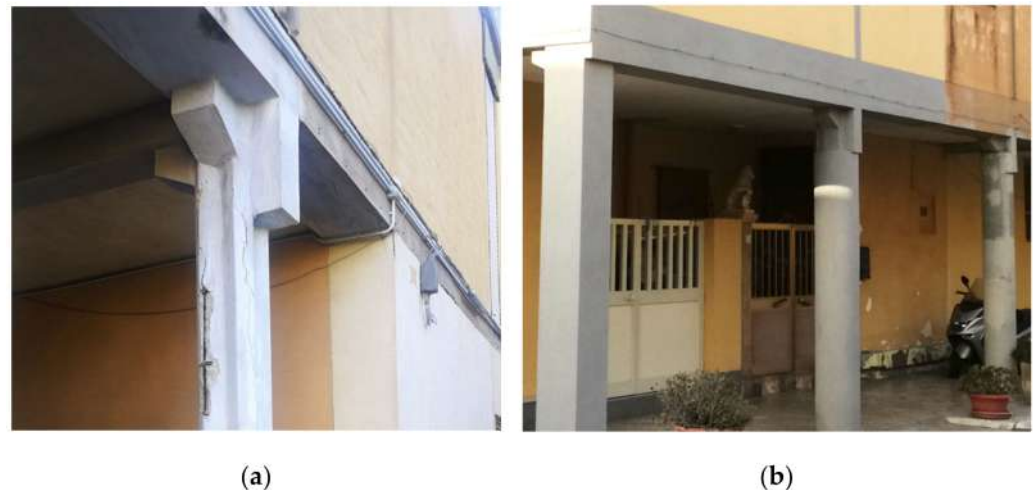
Buildings in the Cappuccinelli district, being close to the sea (about 150 m) and exposed to strong mistral winds, should be equipped with protection systems for reinforced concrete structures in order to significantly reduce the risk of corrosion of the steel reinforcements. However, repairs by the IACP modified the original shape of these building components. As a relevant example, the original shape of the pillars in the porticos (Figure 8a)—a significant architectural detail in the project by Valori—was heavily modified in the renovation works, but their alteration did not make them more effective (Figure 8b).

Figure 8. (a) Original shape of pillars designed by Valori. (b) Consolidation of pillars in the portico of court “B”, executed in 2012. Author: Rossella Corrao.

The design of structural strengthening and rehabilitation works, aimed at overcoming the detected causes of damage (presence of rainwater and sea salts; lack of adequate protection for the reinforcement bars; inadequate structural dimensioning) and complying with current requirements for structural safety, also must consider the architectural concept on which the buildings are based. In this sense, archive research on project development and renovation works carried out in Cappuccinelli were essential to complement the in-situ inspection of the buildings in order to identify the original solutions worth being preserved and the inappropriate repairs.
