Safety of Mosul and Haditha Dams, West Iraq as Affected by Karstification

Abstract

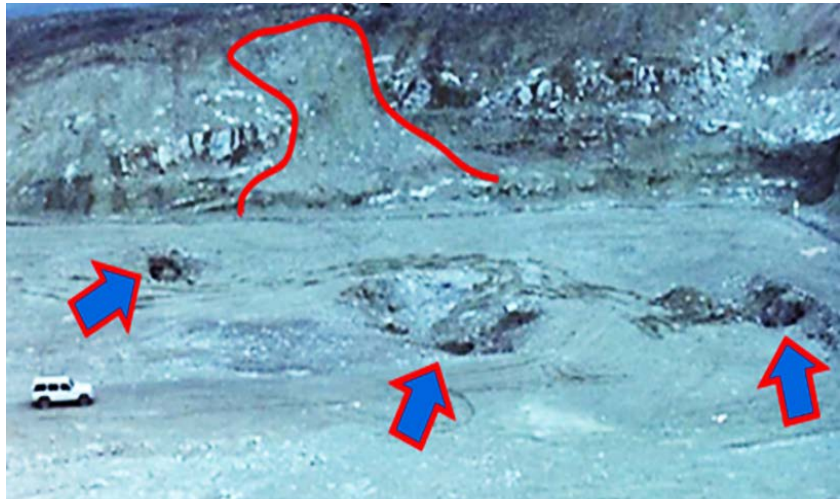
The exposed formation in the dam site and majority of the reservoir area is the Fatha Formation (Figure 2). The formation consists of cyclic deposits, each cycle consists of green marl, limestone, and gypsum; however, in the upper parts, reddish brown claystone occurs in the cycles. The gypsum beds are severely karstified (Figure 3) causing the main problem in the dam's foundation.

Figure 3. A karstified site, 15 km southeast of Mosul Dam, note the karstified gypsum beds (white color) and their total absence in the limited area by the red line (due to dissolution), and the developed sinkholes in the ground (After [8]).

Formation (Middle Miocene age) [5] [14] (**Figure 2**). The gypsum beds in the Fatha Formation are highly karstified, and locally they are totally dissolved leaving voids of different shapes and sizes (**Figure 3**), which are filled by weathered materials from the overlying beds; like gypsiferous clayey soil, limestone, and gypsum fragments [9] [14].

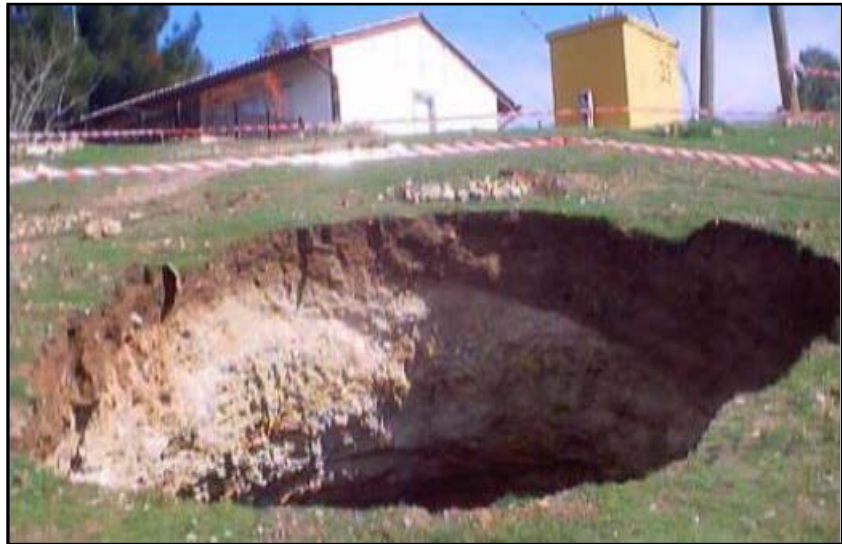
The sinkhole shown in Figure 4 was developed downstream, near the touristic city at the dam site after filling of the reservoir. The authorities of the dam have filled the sinkhole in an attempt to block it, but after two years, the sinkhole was found empty from the dumped materials.

Figure 4. A sinkhole which was developed downstream after filling the reservoir (15 February 2015)

Many gypsum beds can still be seen below the constructed and assumed karstification line (**Figure 8**), and when grouting does not reach these gypsum beds, which are present below the assumed karstification line, then the dissolution of these beds continues due to the high head of the storage water in the reservoir and, the increased groundwater movement. This can be seen clearly from the type of the extracted core (**Figure 9**) where the rocks are in form of small pieces rather than to be in form of continuous masses. This is an excellent indication for the poor status of the rocks in the foundations of the Mosul Dam; therefore, the continuous grouting was not able to block permeability, the voids, and caverns, which are present in the rocks under the foundations. Another good indication for the activity of the karstification is the developed sinkhole in the touristic camp

(Figure 4) at the dam site and the repeated attempts, which took two years to block the sinkhole, but all attempts were in vain. The other mistake was that the grout ability of the karstified gypsum which fills the dissolution cavities was misjudged and these pockets proved to be un-grout able, leaving open windows in the curtain. Moreover, the encountered Terra Rossa formation in the lower

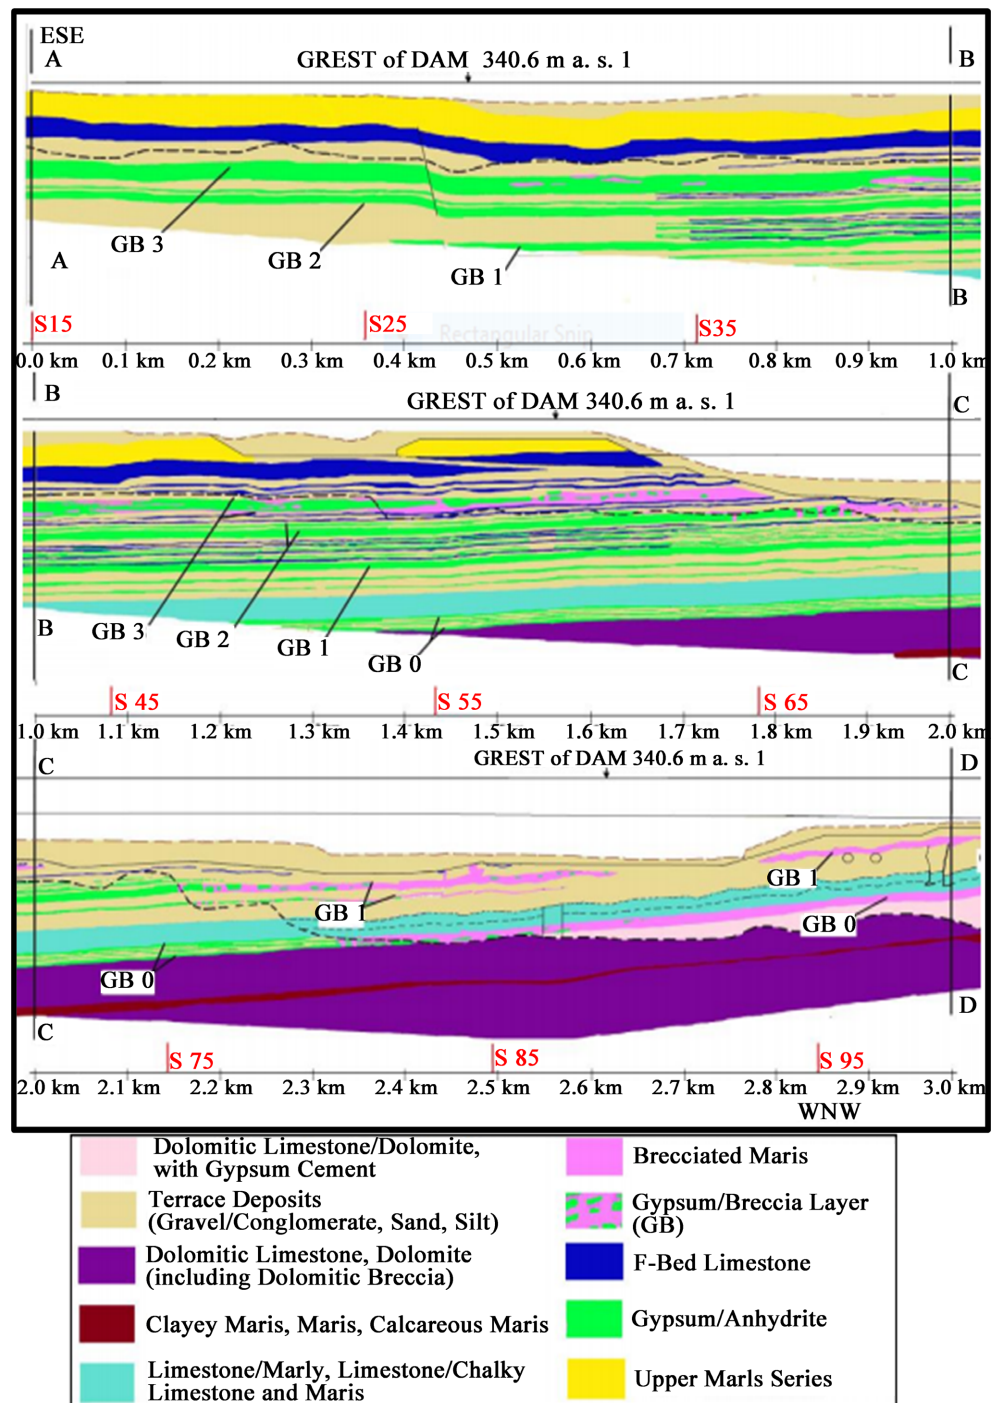
Due to the highly karstified gypsum beds of the Fatha Formation below the foundations of the dam, continuous grouting was carried out starting from the construction stage and has continued ever since as ongoing maintenance process [4]. Total maintenance grouting material quantities used since the end of the contractors' obligations in 1991 up to the end of 2018 has exceeded 210 thousand tons. One of the main reasons for continuous grouting is the miss-interpretation of the acquired data from the extracted cores of the drilled boreholes and the performed permeability tests [12]. Accordingly, the depths of the grouting boreholes were not determined correctly (**Figure 8**).

Figure 8. Geological cross sections along the Mosul Dam site. The dashed black line represents the karstified line. The grouting boreholes were drilled to the depth of the karstified line. Note the existing of gypsum beds below the karstified line (After [2]).

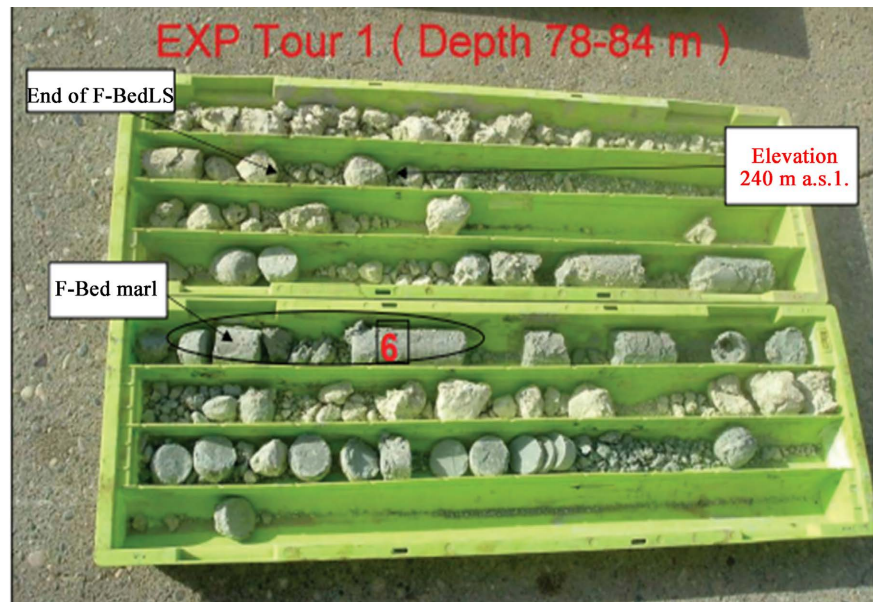
Figure 9. Part of the extracted core at the Mosul Dam Site. Note the poor RQD of the core.
