Article

Effect of the Cyclic Crack Opening-Closure during Epoxy-Curing Period of a CFRP Strengthening System Bonded on Concrete Substrate

Abstract: This article investigates the potential detrimental effects of cyclic load during the installation of externally bonded (EB) carbon fiber-reinforced polymer (CFRP) on a damaged reinforced concrete (RC) structure. Four RC specimens were tested in three point bending to study the consequences of crack cyclic opening-closure during epoxy-curing period. A first RC specimen (without bonded CFRP) was loaded monotonically up to failure to serve as undamaged control sample. The three other specimens were pre-cracked before being subjected to a fatigue loading procedure to simulate service condition of a damaged RC structure. Two of the three pre-cracked specimens were strengthened by EB CFRP. One specimen was repaired before the fatigue test while the other one was repaired during the fatigue test. Finally, remaining capacities of all three pre-cracked specimens were measured through monotonic bending tests until failure. It was found that, although bonding of CFRP reinforcement during cyclic load can induce some interesting features with reg

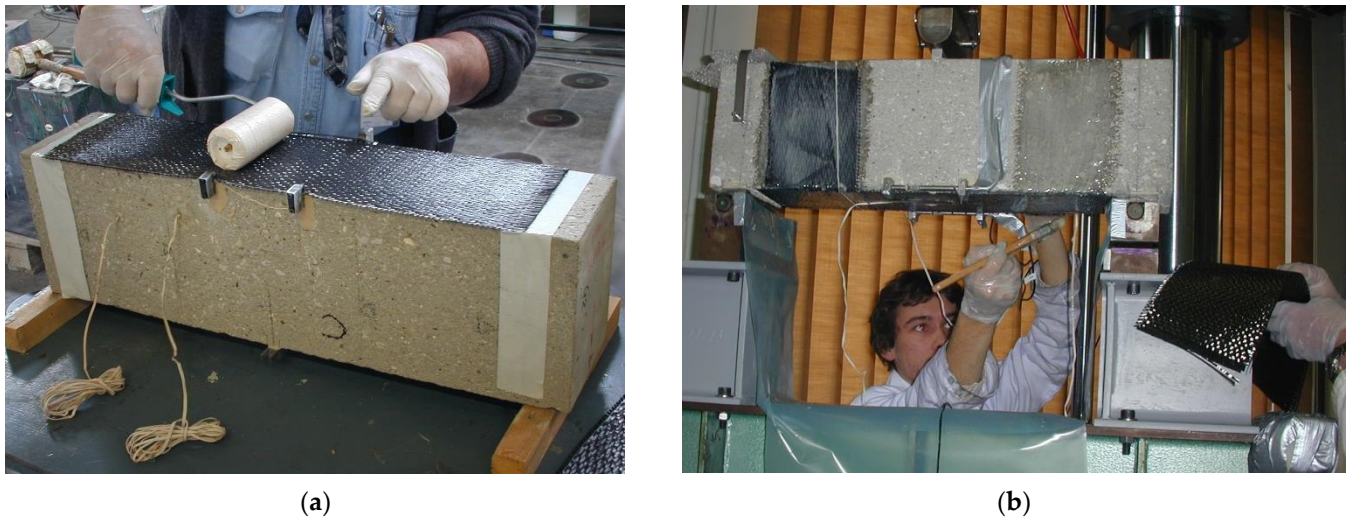
The specimen ES1 was strengthened by EB CFRP just after pre-cracking. A 7 day cure of the epoxy was achieved in the laboratory (without any moving of the specimen) before proceeding of fatigue flexural loading. For the ease of CFRP installation, the beam ES1 was lying upside down during bonding operation (i.e., the beam face subjected to tensile load during the bending test was positioned upward during bonding, see Figure 6a).

Figure 6. Strengthening of specimens: (a) beam ES1 positioned upside down; (b) CFRP strips bonded as in the field (technicians working under the beam ES2).

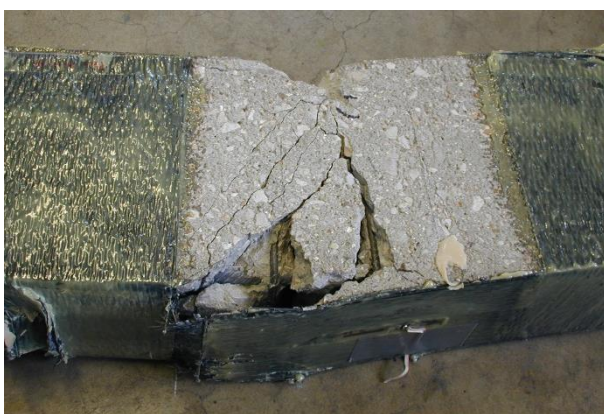
As previously explained, for all beams, the experimental program was achieved by a monotonic bending test to rupture. Failure of specimen NES1 was due to tensile rupture of one longitudinal reinforcing bar (rebar) at mid-span, below the stirrup at the exact location of the first crack. At failure, the initial crack formed a largely open flexural crack. Beam NES2 experimented a similar failure mode. Specimen ES1 failed through tensile fracture of the CFRP longitudinally bonded at the soffit of the beam. The transverse tearing of the carbon sheet occurred at the crossing of the longitudinal layer with the transverse one (Figure 7a). It is to note that the CFRP U-jackets were efficient to prevent debonding at the end of the longitudinal CFRP strengthening, as expected. Before total collapse of the beam, some inclined concrete cracks propagate from the soffit and rise to the initial vertical crack. Considering their inclination (approximately 45 degrees) typical of shear cracks and the location of their initiation (at the soffit) as flexural cracks, these cracks were considered as the consequence of a mixed shear/flexural failure. The large opening of one of this shear crack triggered the tensile failure of the CFRP. Differently, no new concrete cracks appeared with increasing load of the beam ES2 that failed by tensile rupture of CFRP below the largely opened initial flexural crack (Figure 7b).

Figure 7. Observed failure modes of strengthened beams: (a) specimen ES1 (CFRP bonded without cyclic loading); (b) specimen ES2 (CFRP bonded during cyclic loading).

specimens previously presented (Figure 7) show that the CFRP longitudinal strengthening, involving applying a higher load to rupture, changed the failure mechanism of specimens from flexural failure (NES2) to mixed failure mode (shear and flexure failure of ES1).

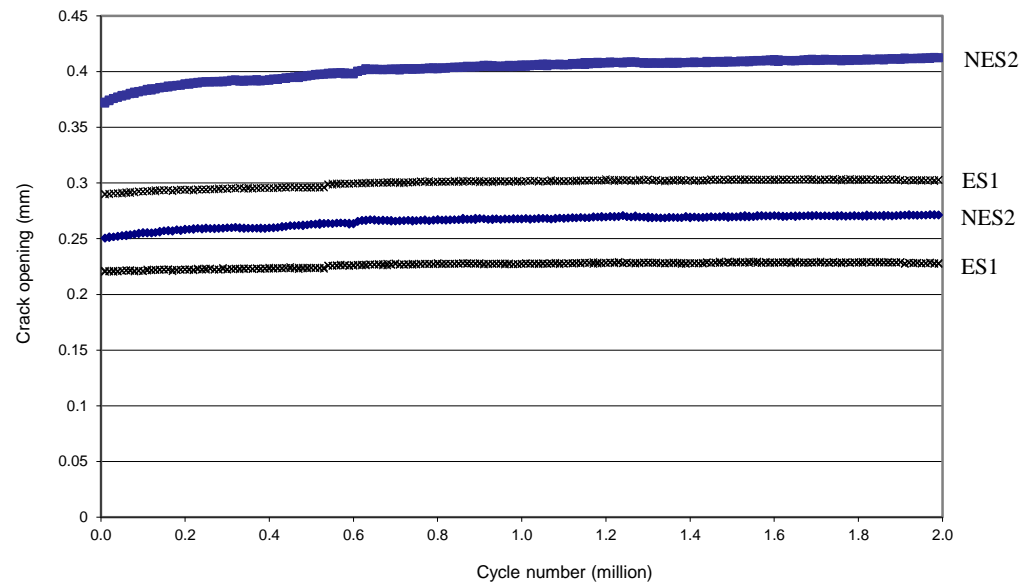
To assess the effectiveness of the bidirectional CFRP strengthening system in the tested configuration (including specimen geometry) when conventionally installed (i.e., without moving during polymerization), the Figure 9 permits to compare the evolution of the crack opening-(partial) closure recorded on beams NES2 and ES1. For each beam, two curves are presented, corresponding to crack opening at minimum and maximum cyclic loads at each cycle. Presented results clearly illustrate the well-known crack bridging effect of the EB strengthening that lowered the crack opening. In addition, it can be observed in Figure 9, that bonded CFRP also lowered the evolution of the maximum crack opening during cycles: for NES2 maximum crack opening evolves from 0.372 mm to 0.412 mm (+10.98%) while it only evolves from 0.290 mm to 0.303 mm (+4.24%) for ES1. Moreover, failure modes of

Figure 9. Evolution of crack opening extremes during fatigue tests of NES2 and ES1.
