Analysis of Renovation Works in Cappuccinelli Social Housing District in Trapani

Rossella Corrao ^{1,*} , Erica La Placa ¹ , Enrico Genova ² and Calogero Vinci ¹

Keywords: social housing; renovation works; energy efficiency improvement; Cappuccinelli Social Housing district; Trapani

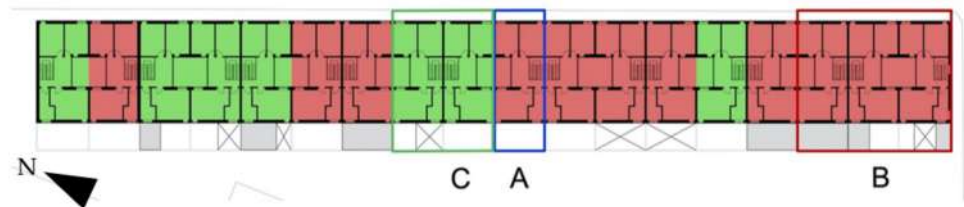
A public body (IACP) currently owns seven of the 18 dwellings in block “L” (Figure 4). The only apartment not altered from the project by Valori is owned by a private party and suffers from more severe degradation than the other apartments in the building. Both the geometric and material features of this dwelling have been analyzed.

Figure 4. Ground floor of “L” block. Dwellings still owned by IACP are shown in green and private dwellings are shown in red. The blue rectangle identifies the apartment where the project by Valori has not been altered. Source: Archive IACP Trapani.
